# Manhole Inspection Summary

Manhole # S17K1\_003MH

Insp Date: **4/30/08 12:54 PM**

**Location** Address: **3205 mardel av**

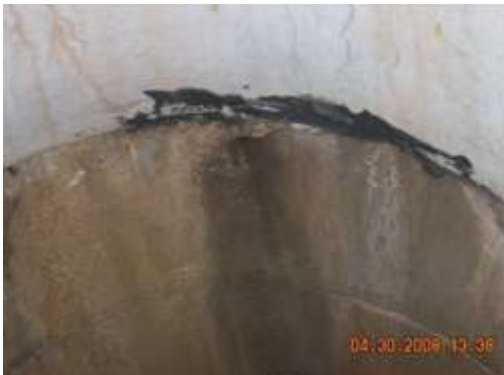
Defect 2

Infiltration: ☐ None ☒ **Joint** ☐ Cracks ☐ Mortar ☐ Roots ☐ Wall

infiltration @ barrel/corbel joint

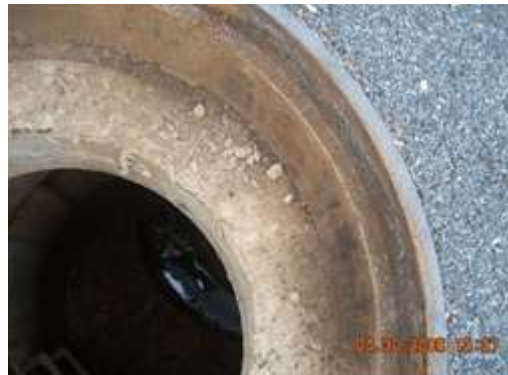
Defect 1

Offset: **5** (in.)

frame offset

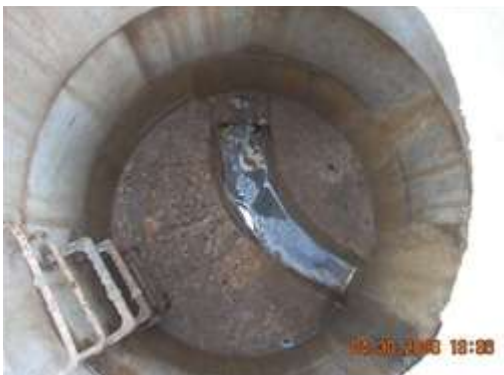
Defect

Count: **7** Missing: **0** ☒ **Corroded**

corroded steps

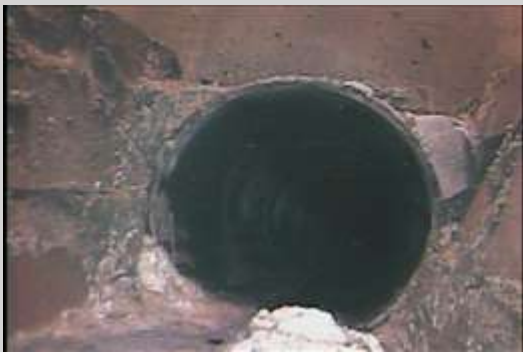
12 O'Clock Outflow

Pipe Height: **8.4** (in.) Rod and Bar (Angled)  
Pipe Material: **Unknown** ☐ Pipe Lined  
Invert Depth: **9.09** (ft.) Flow Characteristics: **Slow**  
Deposits: ☐ None ☒ **Mud** ☐ Sludge ☒ **Debris** ☐ Grease  
Silt Depth: **1** (in.) Deposits Extent: **Light**  
Infiltration: **None** Pipe Seal Cond: **Sound**

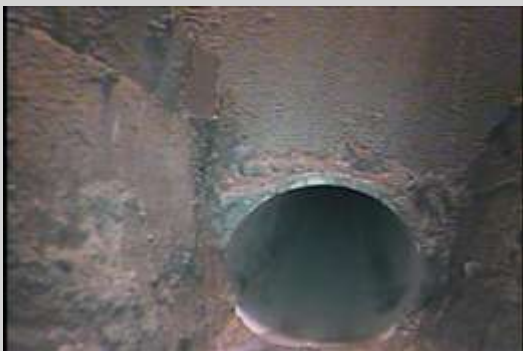
4 O'Clock Inflow

Pipe Height: **6** (in.) Rod and Bar (Angled)  
Pipe Material: **Clay** ☐ Pipe Lined  
Invert Depth: **9.00** (ft.) Flow Characteristics: **Slow**  
Deposits: ☒ **None** ☐ Mud ☐ Sludge ☐ Debris ☐ Grease  
Silt Depth: **0** (in.) Deposits Extent:  
Infiltration: **None** Pipe Seal Cond: **Sound**
